Manhole Inspection Summary

Manhole # S53C__016MH

Insp Date: **6/12/08 2:26 PM**

Location Address: **3107 e fairmount st**

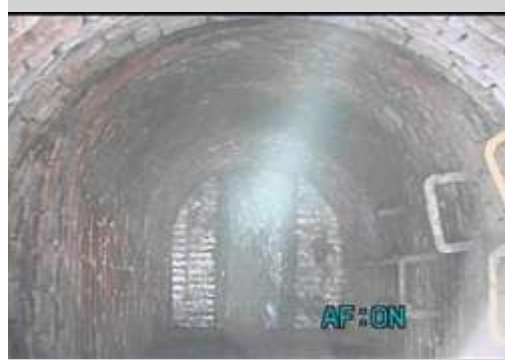
Top View

not d shaped, can see more from 2nd top view

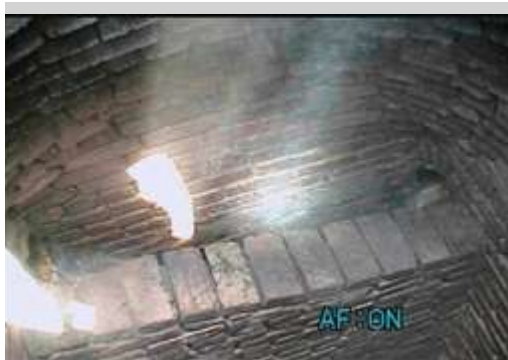
misc

shelf containing pipes 3 & 9 drops down to above 6

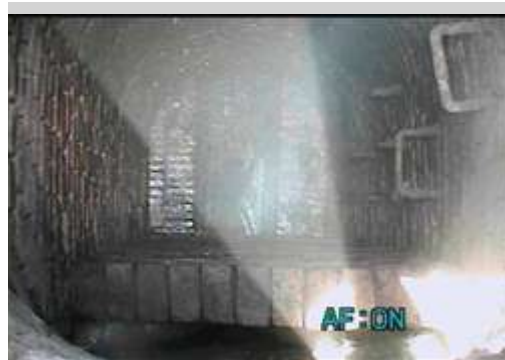
Miscellaneous

2nd top view

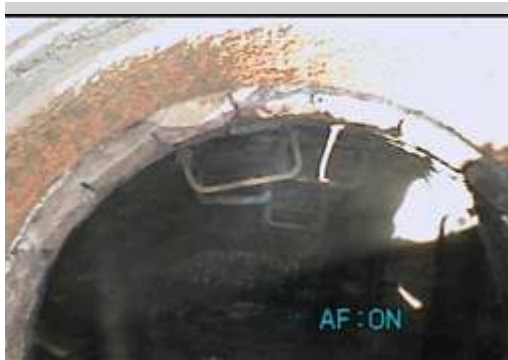
Defect 2

Count: **9** Missing: **5** ☒ **Corroded**

steps

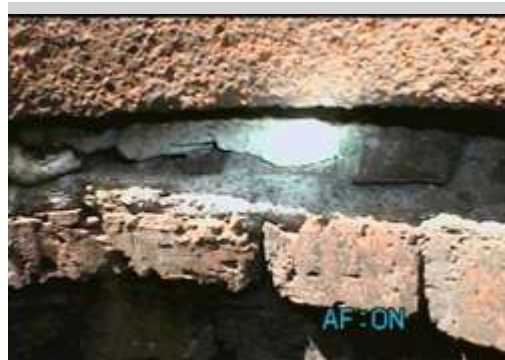
Defect 1

Condition: ☐ Sound ☐ Cracked ☐ Root Intrusion ☐ Loose Brick ☒ **Deteriorated**

Chimney deteriorated, frame adj

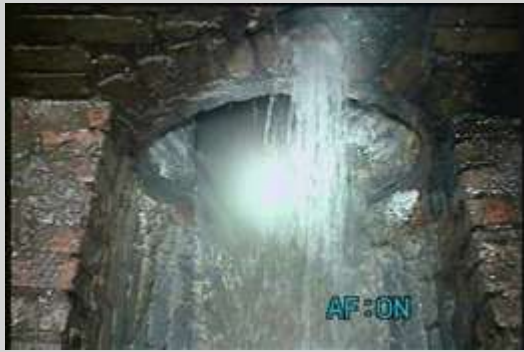
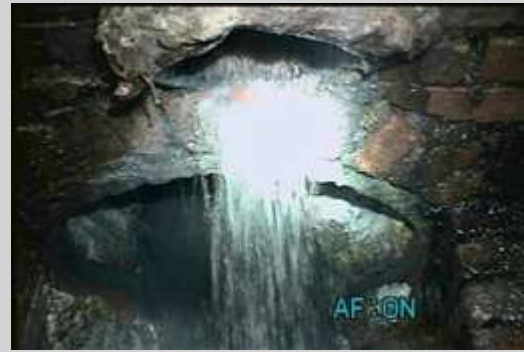
6 O'Clock Inflow

top flow is from 3 & 9

Drop: **Inside** **Direct**
